6  
STRUCTURE, STABILITY AND TOUGHNESS  
OF (Co,Cr)-(Cr,Co)<sub>7</sub>C<sub>3</sub>

10  
L. Y. Lin, M. H. AbdelLatif and A. Lawley

11  
November 1978

Drexel University  
Department of Materials Engineering  
Philadelphia, Pennsylvania 19104

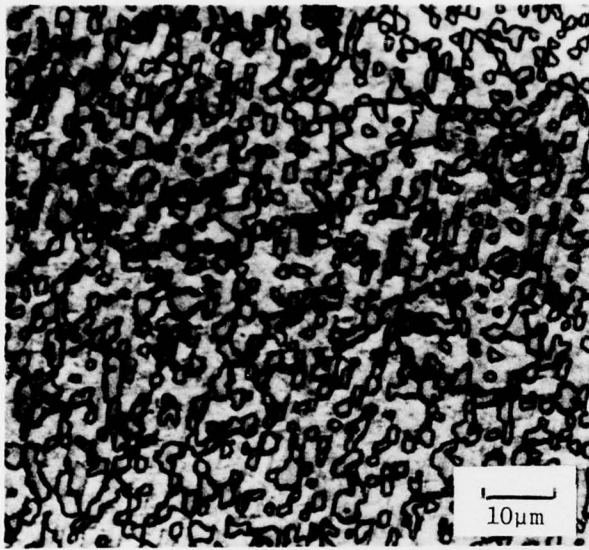
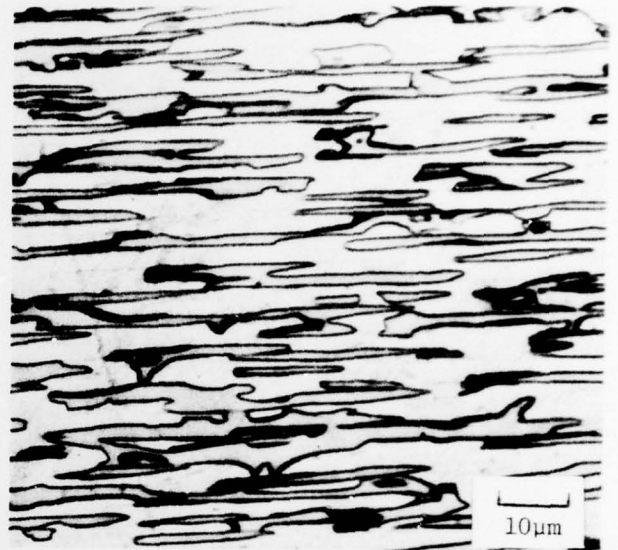
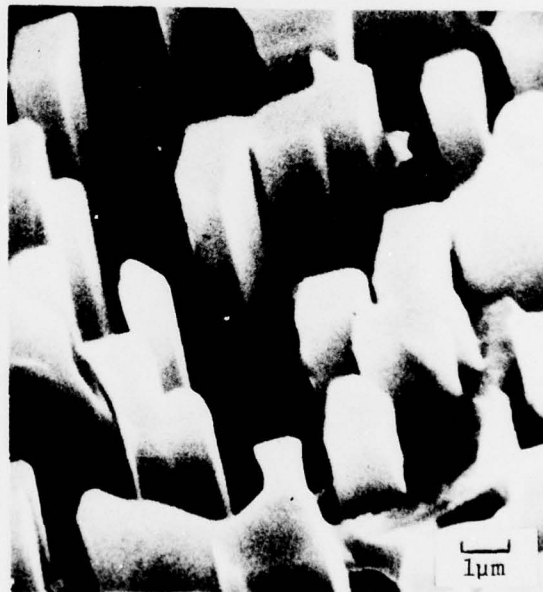
Figure 2. Microstructure of the as-grown composite: a) transverse; b) longitudinal sections; c) fiber morphology (SEM).

Optical micrographs of the as-grown composites are illustrated in Figures 2(a) and 2(b) for the transverse and longitudinal orientations, respectively. Consistent with previous observations on this system by Thompson and Lemkey (6), the aligned fibrous carbide reinforcement is highly irregular in terms of cross-sectional dimensions and geometry. Extensive branching of the carbide is evident and aspect-ratio varies over a wide range. Similarly the inter carbide spacing varies about a mean of  $\sim 4\mu m$ . This is again comparable to the scale of the microstructure reported by Thompson and Lemkey for similar growth rates (6). Faceting of fiber cross-sections is evident in transverse microstructures (Figure 2(a)) and is further illustrated by scanning electron microscopy, Figure 2(c). In the latter micrograph, the matrix has been etched away to reveal fiber morphology and

surface condition. Fiber surfaces in the as-grown composite are relatively smooth. Faceting reflects hexagonal symmetry of the carbide reinforcement.

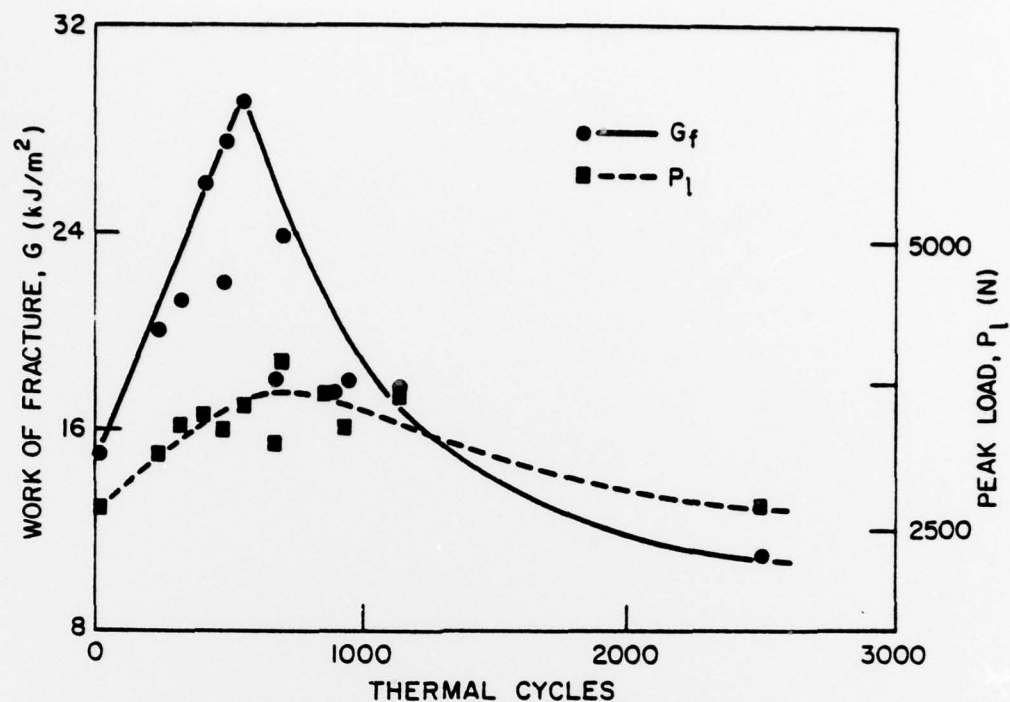
Figure 3. Work of fracture ( $G_f$ ) and peak load ( $P_l$ ) as a function of thermal cycling between 80°C and 1121°C.

The effect of the three thermal cycling regimes on work of fracture  $G_f$  and peak load  $P_\ell$  is shown in Figures 3, 4 and 5, and for the superimposed hold time at  $T_{\text{max}}$  in Figure 6. The corresponding dependence of  $G_f$  and  $P_\ell$  on isothermal exposure is given in Figure 7. The extent of the 'tail' area was similar to that in the as-grown condition; no significant differences could be established between the various thermal treatments and the extent of the 'tail' area.

a decrease in both parameters. Such an increase in both  $G_f$  and  $P_\ell$  reflects an enhancement of the mechanical properties. However, the increase in  $G_f$  is the more significant of the two; thus,  $G_f$  reaches a value about twice that for the material in the directionally solidified condition. It is also interesting to observe that while  $G_f$  peaks and then decreases, the level of  $G_f$  after 3000 cycles is still at or close to that of the as-grown material. The worst condition in terms of the level of  $G_f$  occurs for the thermal cycling treatment with the maximum  $\Delta T$ , i.e., 80°C to 1121°C, Figure 3. Here there is a decrease ~25% in  $G_f$  after 2500 cycles.

The initial increase in  $G_f$  and  $P_\ell$  on thermal cycling is attributed to axial thermal mismatch stresses caused by the difference in thermal expansion coefficients of the two constituents in the composite (9-11). These stresses have been calculated for each of the thermal cycling programs used (12); they reach a maximum at  $T_{\min}$  and a minimum at  $T_{\max}$ . Such stresses could lead to cyclic thermal fatigue hardening. The magnitude of these thermal residual stresses is proportional to  $\Delta T$ . It is therefore expected that their effect on  $G_f$  and  $P_\ell$  (measured in terms of peak values) will be more pronounced in the thermal cycling regime having the largest ( $T_{\max} - T_{\min}$ ) difference. This is, in fact, the case as seen by a comparison of Figures 3, 4 and 5; the 80°C to 1121°C excursions maximize the increases in  $G_f$  and  $P_\ell$ , Figure 3.

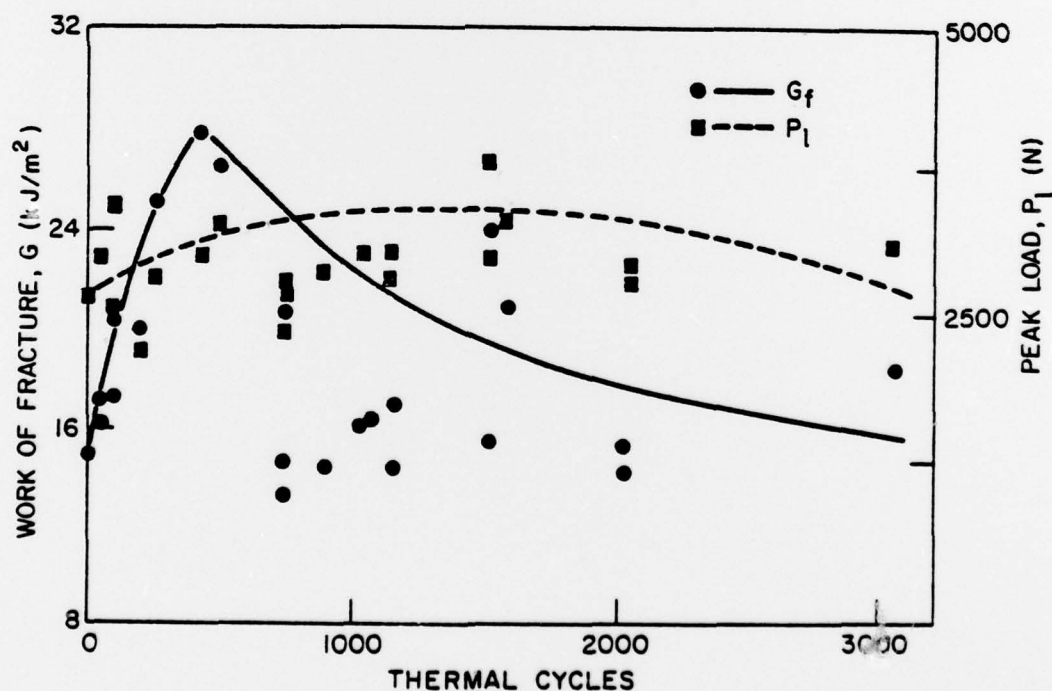
Figure 4. Work of fracture ( $G_f$ ) and peak load ( $P_l$ ) as a function of thermal cycling between 400°C and 1121°C.

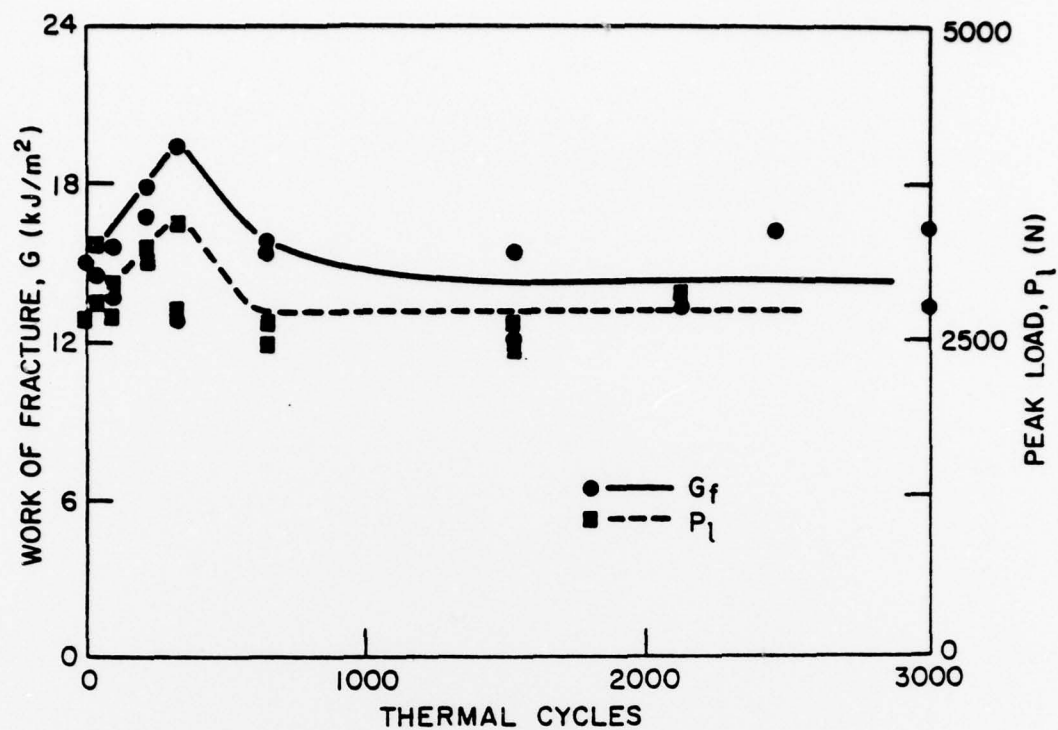
Figure 5. Work of fracture ( $G_f$ ) and peak load ( $P_l$ ) as a function of thermal cycling between 538°C and 1121°C.

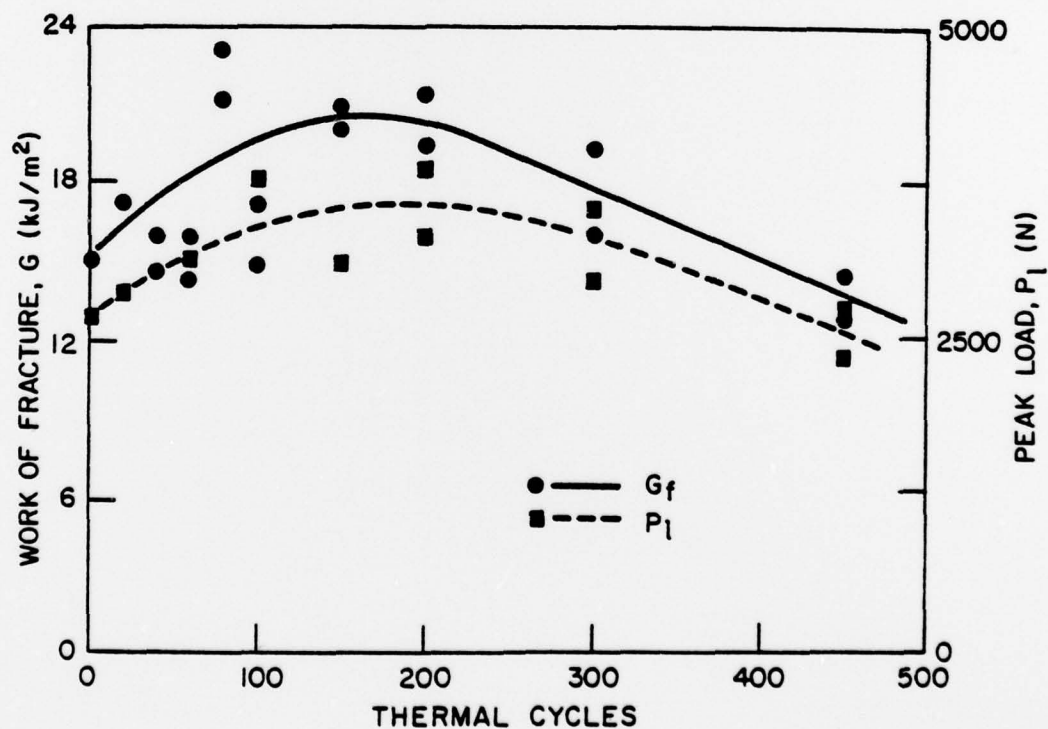
Figure 6. Work of fracture ( $G_f$ ) and peak load ( $P_l$ ) as a function of thermal cycling (400°C to 1121°C) with a hold time of 3600s at  $T_{max}$ .

The variation of  $G_f$  and  $P_\lambda$  with cyclic treatment involving a superimposed hold time is similar to that described above, Figure 6. Increases in  $G_f$  and  $P_\lambda$  with cycling are less pronounced as compared to thermal cycling with no hold time. With a hold time imposed at  $T_{\max}$  there will be a longer time available for matrix creep, dynamic recovery or fiber degradation; individually or in combination, these could give rise to a lower increment in  $G_f$  or  $P_\lambda$  on thermal cycling compared to the increment resulting from thermal cycling without hold time.

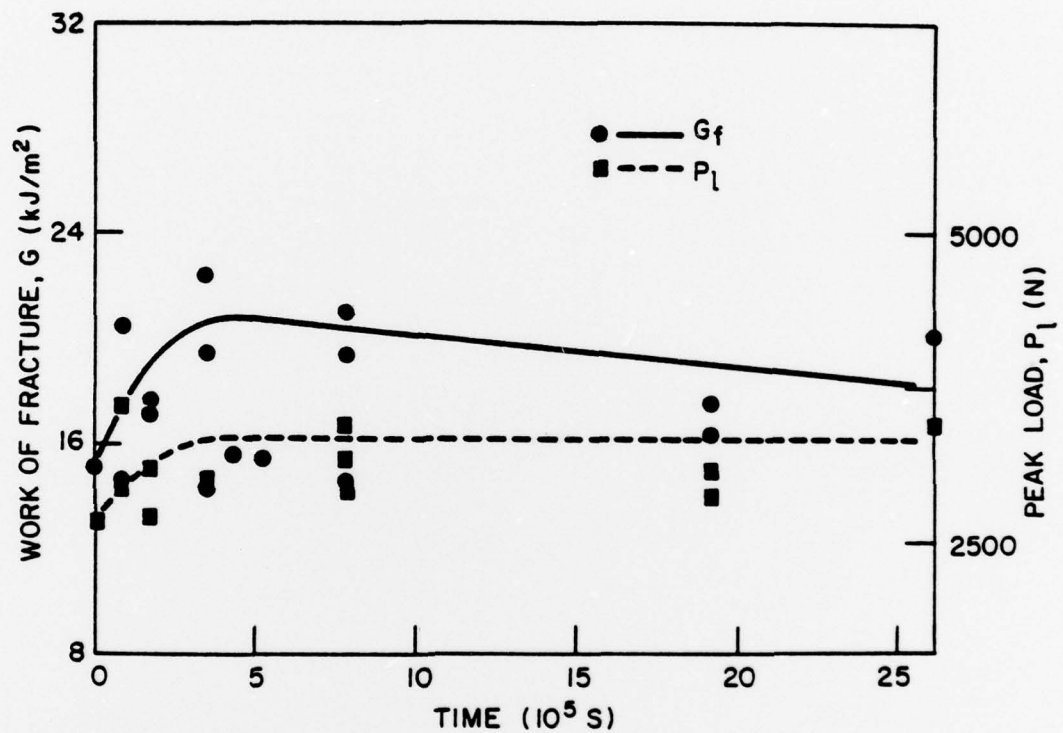
Figure 7. Work of fracture ( $G_f$ ) and peak load ( $P_l$ ) as a function of isothermal treatment at 1121°C.

Both  $G_f$  and  $P_\lambda$  increase with isothermal treatment at 1121°C, Figure 7. Work of fracture  $G_f$  reaches a maximum after about five days ( $\sim 4 \times 10^5$  s) then decreases slightly but to a level higher than that of  $G_f$  in the as-grown condition. Peak load  $P_\lambda$  increases over the same time scale and then remains constant. This confirms the excellent high-temperature stability of this composite at a homologous temperature of 0.89. Microstructurally, after isothermal exposure, fibers look similar to those in the as-grown composite. An example is shown of fibers after  $18 \times 10^5$  s at 1121°C in Figure 8(c). There is no evidence of surface degradation or serrations. Further studies are needed to arrive at a deeper understanding of the transient increases in  $G_f$  and  $P_\lambda$  in terms of microstructural change(s) brought about by isothermal exposure and/or thermal cycling.

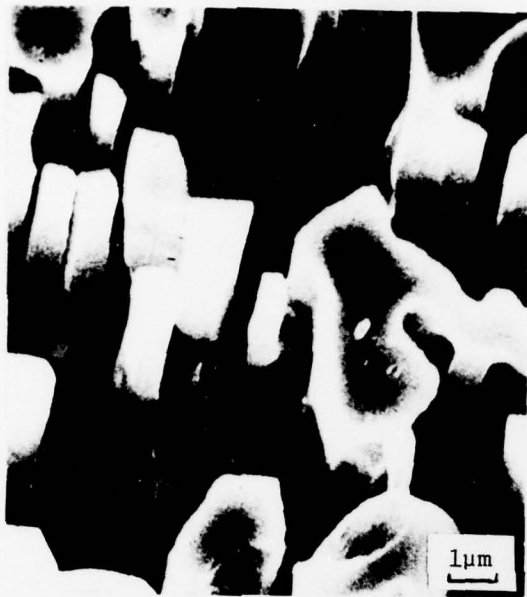
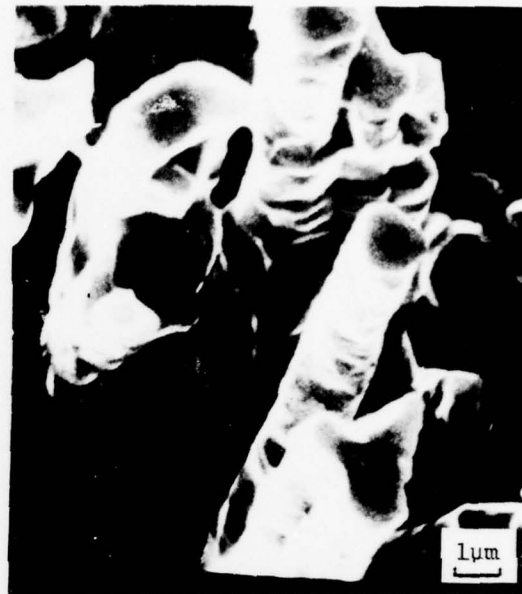
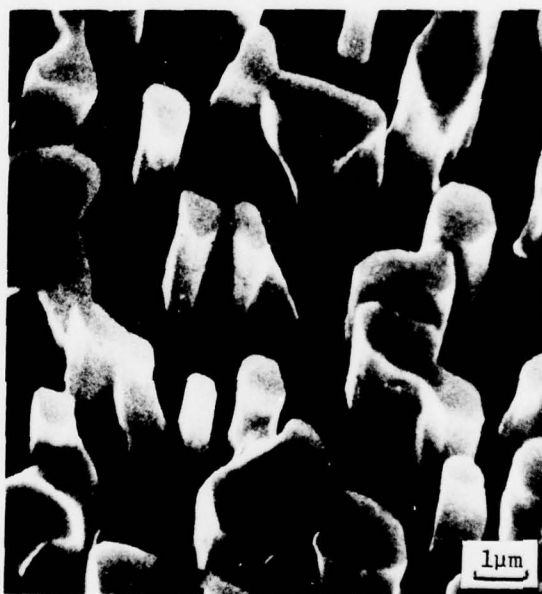
Figure 8. Scanning electron micrographs of thermally treated composites after deep-etching to reveal fiber morphology:

- (a) 3000 cycles between 538°C and 1121°C
- (b) 3057 cycles between 400°C and 1121°C
- (c)  $180 \times 10^4$  s at 1121°C.

Subsequent decreases in  $G_f$  and  $P_\ell$  may be explained on the basis of relaxation of the thermal stresses, either by matrix creep or dynamic recovery. A further factor could be fiber degradation during thermal cycling. There is no apparent fiber degradation after 3000 cycles between 538°C and 1121°C, Figure 8(a). However, some degradation, as reflected in fiber surface appearance, is noted after 3057 cycles between 400°C and 1121°C, Figure 8(b).

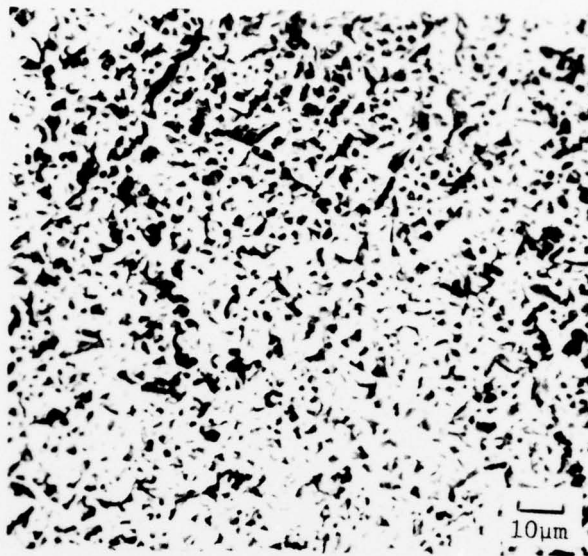
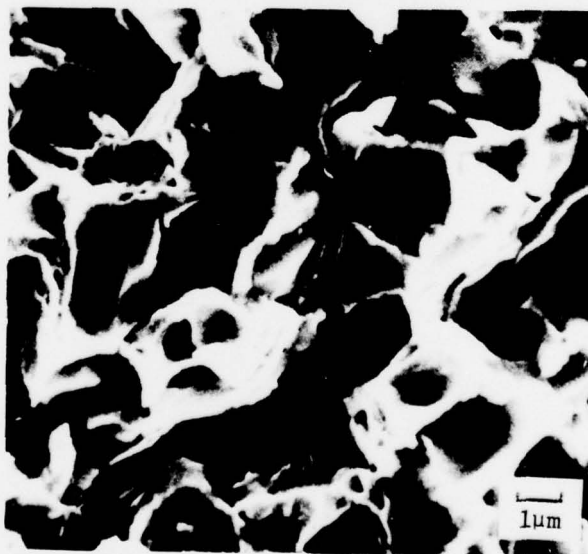
Figure 9. Scanning electron micrographs of fracture surfaces of a thermally cycled composite: 431 cycles between 400°C and 1121°C.

On a macroscopic scale, the fracture surfaces of thermally cycled and isothermally treated composites are relatively flat indicative of brittle fracture. Microscopically, the fibers fail in a brittle mode accompanied by ductile fracture of the matrix. The matrix shears to link the fiber (cleavage) breaks, Figure 9(a). There was no evidence for fiber pull-out or delamination at fiber matrix interfaces. Thus, these are not operative sources of energy absorption as the crack propagates through the ligament. The absence of delamination is a characteristic of in-situ composites and

reflects integrity of the low energy interface between matrix and reinforcement (1). Some occasional fiber splitting in the longitudinal direction of the fibers was observed. Figure 9(b) shows this phenomenon after thermal cycling between 400°C and 1121°C. This has the beneficial effect of diverting a propagating crack, thereby enhancing toughness. Thompson (3) has suggested that the splitting may be caused by the stress generated at the boundary between the plastic and elastic zone at the tip of the crack propagating in the matrix.
